Non-Invasive retrofit from pneumatic to DDC

for 2025 Florida Healthcare Engineering Association Educational Conference

Harry Sim, Cypress Envirosystems

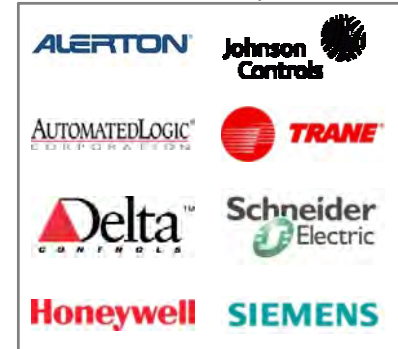
BACnet interface compatible with:

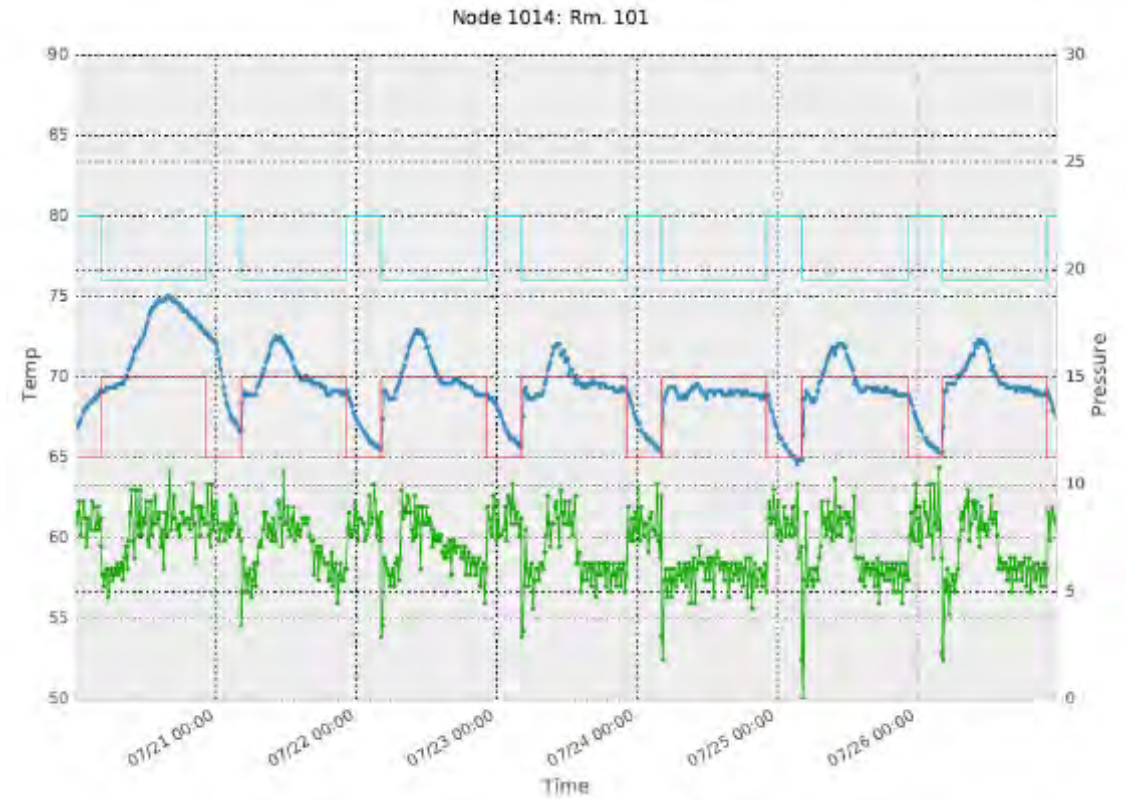
Visibility: Enables Trending of Key Pneumatic Parameters

- Monitor, Trend, Alarm, Notify on Zone Temperatures, Setpoint Temperature(s), Branch Pressure, and Relative Humidity.
- BACNet Integration – control and view via BAS, or directly via GBC Controller.
- Know who is uncomfortable before they complain.

Green Line = Branch Pressure
Dark Blue Line = Room Temperature
Light Blue Line = Cooling Setpoint
Red Line = Heating Setpoint

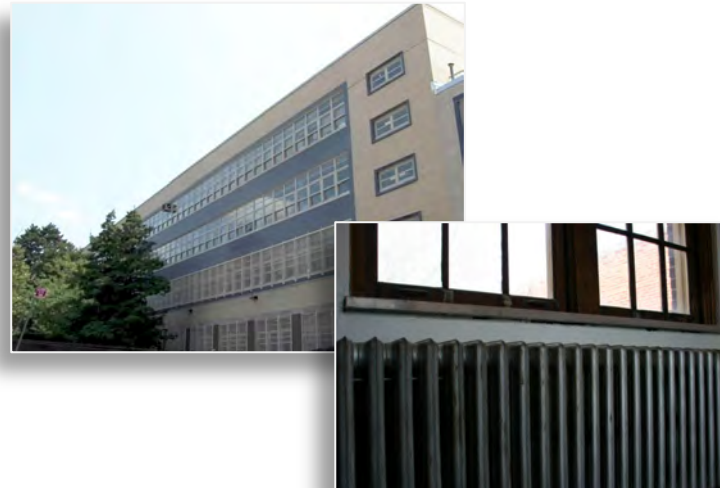
- Edward Hart Middle school Queens, NYC
- Uses Oil Fired Boilers, hot water radiators
- Fault detection, example:
 - Radiator hot water valve stuck open
 - Undetected probably many years
 - Occupants open window to compensate
 - Maintenance staff stretched thin, no data, not aware of situation

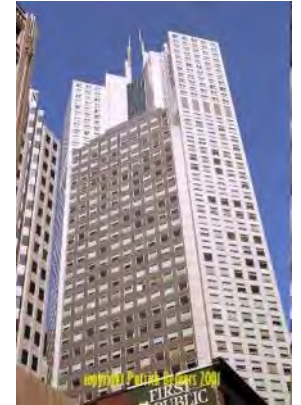
Reduced Hot/Cold Calls – 345 California St, San Francisco

- 17,000 sq-ft Class A Office Space, 31st Floor
- 48 Story Hi-Rise, managed by Cushman & Wakefield
- San Francisco Financial District
- Tenant: Private Equity Firm

Pre-WPT Installation Mar - Nov

W.O.#	DATE	TENANT	FLOOR	OFFICE #	REQUEST	TEMP.	WORK PERFORMED	BY	#
148516	9-Mar-09		31	3115	COLD		FOUND STAT PUTTING OUT 1#	JIM	1
150125	6-Apr-09		31	LARGE CONF.	FRE COOL		PUT STAT INTO COOLING FOR MTNG.	TIM	2
150195	8-Apr-09		31	CONF ROOM	COLD		CAL. T-STAT AND SET TO 70-74	PAUL	3
150500	15-Apr-09		31	3146	COLD	70	OFFICE TEMP. WAS 70	PAUL	4
151016	27-Apr-09		31	3155	COLD	71	TEMP. WAS 71	FRAZER	5
153307	15-Jun-09		31	CONF ROOM	HOT	73	AMBIENT 73 LOWERED STAT TO 65/70	PAUL	6
153976	26-Jun-09		31	EAST CORNER	COLD	73	RM TEMP 73 RAISED STAT TO 74	JIM	7
153991	26-Jun-09		31	PINE SIDE	COLD	73	AREA TEMP. 73. RAISED STAT TO 74	JIM	8
N/A	6-Jul-09		31	3156	COLD	71	OFFICE TEMP. WAS 71	PAUL	9
154347	7-Jul-09		31	S. ADMIN	COLD	72	AREA TEMP WAS 72	C.V/ PF	10
155020	22-Jul-09		31	3115	COLD	71	AREA TEMP AT 71 F, T*STAT AT 75 F	ART	11
155582	5-Aug-09		31	3134-A	COLD	73	AREA TEMP WAS 73.	CRAIG	12
155597	5-Aug-09		31	N CONF RM	COLD		T*STAT SET TO 65-69, RESET TO 70-73	ARTURO	13

W.O.#	DATE	TENANT	FLOOR	OFFICE #	REQUEST	TEMP.	WORK PERFORMED	BY	#
164055	1-Mar-10		31	3155	COLD	69	NEW W.P.T. WAS SET AT 71, SET TO 74	PAUL	1
164473	5-Mar-10		31	3113	COLD	71	FOUND COAT HANGING OVER T-STAT	PHIL	2
164916	12-Mar-10		31	3134A	COLD	72	SUPPLY AIR AT 68F STAT SET @ 72. RAISED TO 73	ART	3
165486	25-Mar-10		31	3120A & B	COLD	72	RAISED SPT. TO 73	CRAIG	4
166825	27-Apr-10		31	3120A & B	COLD	72	WPT WAS SET TO 73, RAISED TO 74	PAUL	5
166853	27-Apr-10		31	3121	HOT	77	UNABLE TO CALIBRATE WPT WILL FOLLOW-UP	PHIL	6
166994	3-May-10		31	3121	HOT	76	FOLLOW-UP TO REPLACEMENT OF WPT BY	CRAIG	7
169919	28-Jun-10		31	3155	COLD	70	RESET STAT TO 72	CRAIG	8
174033	27-Sep-10		31	PINE SIDE	HOT	80	CALIBRATED (3X) STATS AND SET AT 70 F.	CRAIG	9
176108	17-Nov-10		31	3155	COLD	70	STAT WAS SET @ 71 RAISED TO 73	PAUL	10

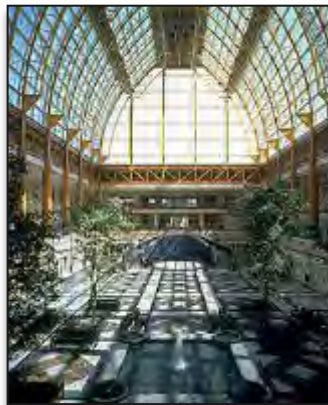
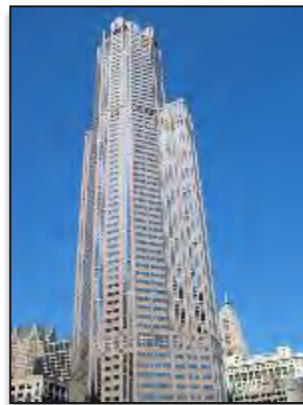
311 SOUTH WACKER DRIVE CASE STUDY

- 65 story tower, built in 1990
- 1.4 million sq-ft
- Utility validated energy savings of 30% per year
- Payback period of 1.8 years with ComEd incentive (3.6 years without incentive).

PROJECT SNAPSHOT	
Customer	311 South Wacker
Measures implemented	Wireless pneumatic thermostats connected to an energy management system; Lighting
Total project cost	\$970,187
Estimated annual energy savings	4,384,242 kWh
Estimated annual cost savings	\$925,000*
Smart Ideas incentive received	\$402,315
Estimated payback period without incentive	2.7 years
Estimated payback period with incentive	1.4 years

THE SOLUTION
With incentives from the ComEd Smart Ideas® Energy Efficiency Program, Zeller Realty Group upgraded 311 South Wacker's energy management system and common area lighting. They installed and connected 944 wireless pneumatic thermostats to an Internet-enabled energy management system that tracks and controls electricity use through a computerized network of monitors and sensors. As part of the building retrofit, 296 inefficient T12 fluorescent lamps were replaced with T8 fluorescent lighting and 95 high-wattage PAR lamps were replaced with LED lights. The new lighting offers a decrease in electricity use as well as improved light quality, uniformity,

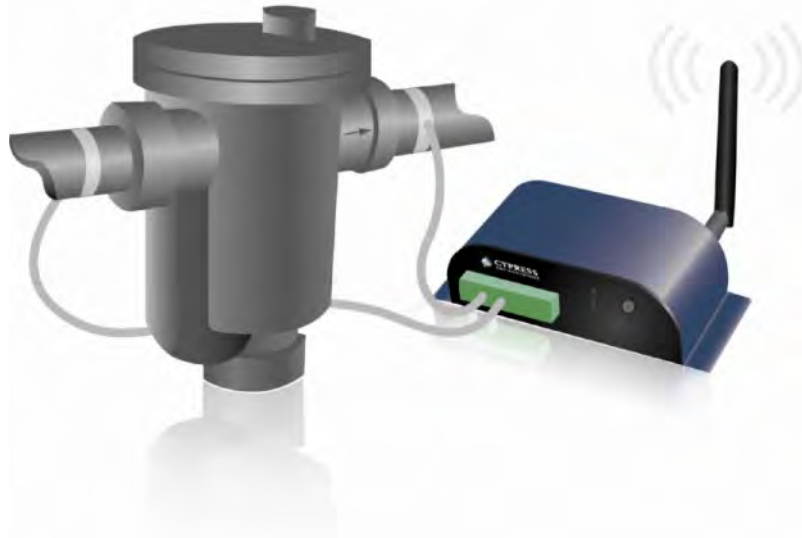
CYPRESS ENVIROSYSTEMS WIRELESS STEAM TRAP MONITOR

- Necessary part of the steam distribution system, usually hundreds of units per site
- 15-20% average failure rate; leaks steam
- Failed traps lose \$5,000 per year (1/8" orifice)
- Manual inspection typically done annually – labor intensive, do not catch problems in timely manner
- Solution: Wireless steam trap monitor detects faults and alarms on error, avoiding expensive leak loss
- Non-invasive installation: no breaking seals, wireless, integrates with BMS
- Battery life of 3+ years at typical sample rates
- IP65/NEMA 4 rated for outdoor use
- One year payback on investment

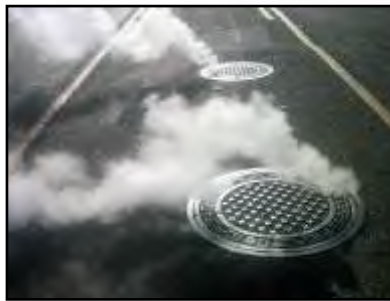
Leaking Traps Waste Energy

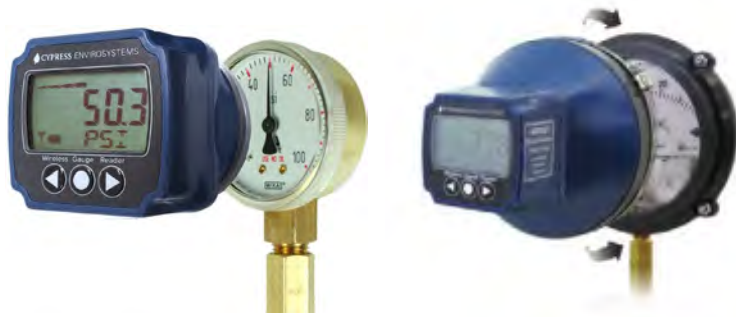
Wireless Gauge Reader

- “Electronic Eyeball” reads gauges and transmits readings wirelessly
- Non-invasive, clamp-on to existing gauges in minutes
- No downtime, no leak check, no wiring, no drawings
- Battery life of 3+ years at 15 minute sample rate
- IP56/NEMA 4 rated for outdoor use
- Various size and types of mounting adapters to fit most existing gauges
- Reads dial gauges, hour meters, LED/LCD displays

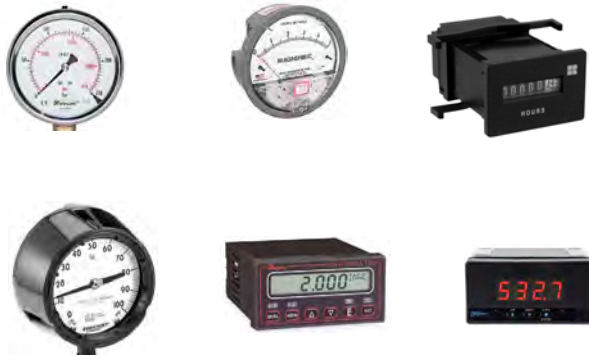
Compatible with most dial gauges, hour meters, panel meters:

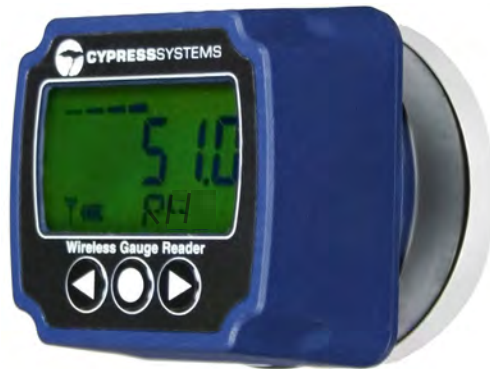
Wireless Humidity and Temperature Monitor

- -20 °C to +70 °C (-4 °F to 158 °F) Temperature Range
- 0 – 100% Relative Humidity Range
- Magnetic Mounting for steel walls or columns
- Adhesive Mounting for other surfaces
- Battery life of 3+ years at 15 minute sample rate
- IP56/NEMA 4 rated for outdoor use

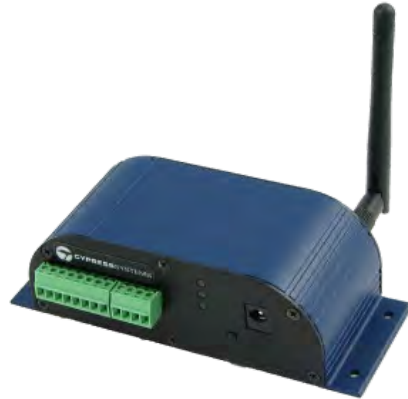
Wireless Transducer Reader

- Enables wireless remote monitoring of virtually any analog transducer or instrument with the following outputs: 4-20mA, 0-5V, or 0-10V, RS-232, RS-485, thermocouple, thermistor
- Compatible with most existing flow meters, current meters, particle counters, thermocouples, weigh scales, etc.
- Battery life of 3+ years at 15 minute sample rate
- Optional enclosures for NEMA 6, IP 67 protection
- Enables data logging to enable trend analysis, notification, or statistical process control
